Re: January 2016 Monthly Progress Report
Administrative Settlement Agreement and Order on Consent for Removal Action
U.S. EPA Region 10 Docket No. CERCLA 10-2009-0255
Gasco Sediments Site within the Portland Harbor Superfund Site

Visual Observations Log Form

Monitoring Period: Monthly (Year 10)— January 2016

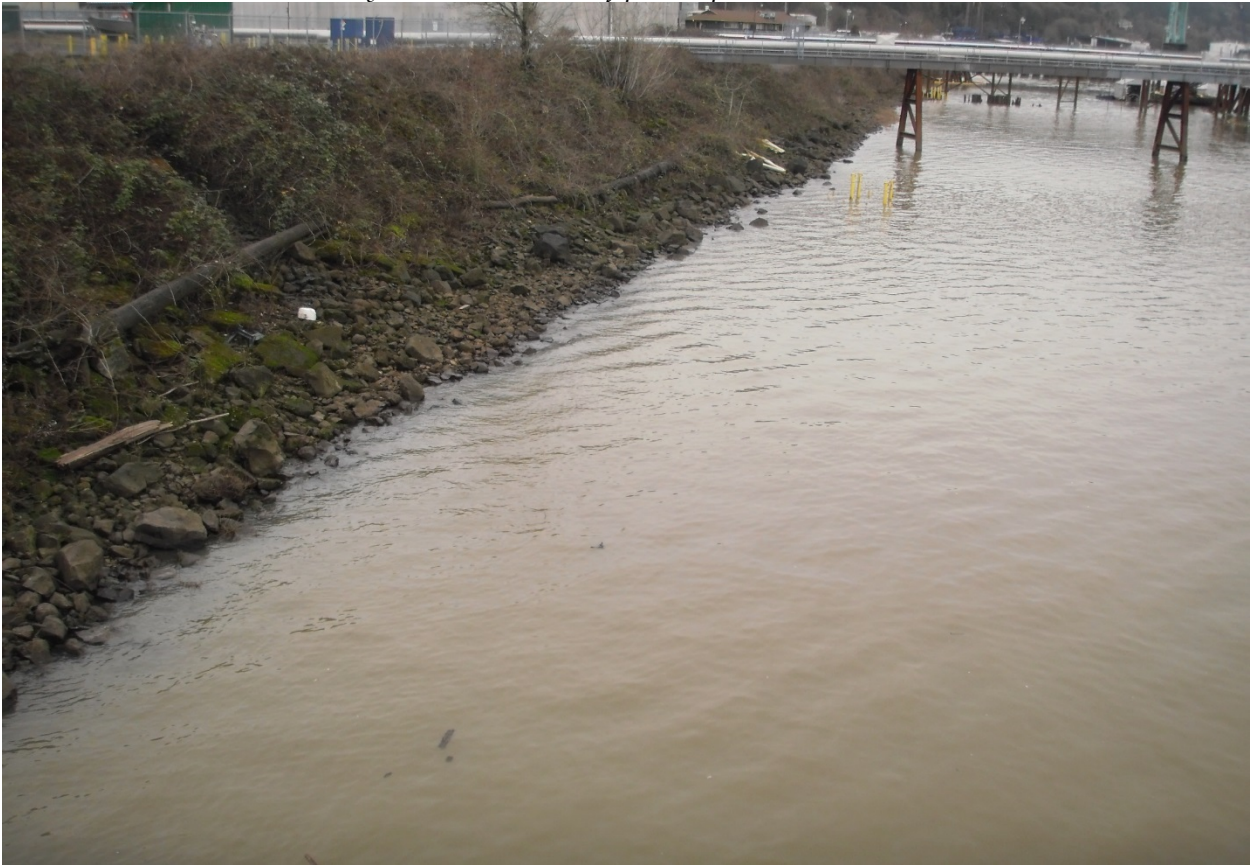
Observations of Erosion/Deposition: No erosion/deposition is evident along the shoreline. The shoreward extent of the cap was not visible due to high river water elevation and the extents of the organoclay mat material were also submerged. (Photo 1).

Photo 1 — *River level currently above the extents of pilot cap area. (1/20/16):*

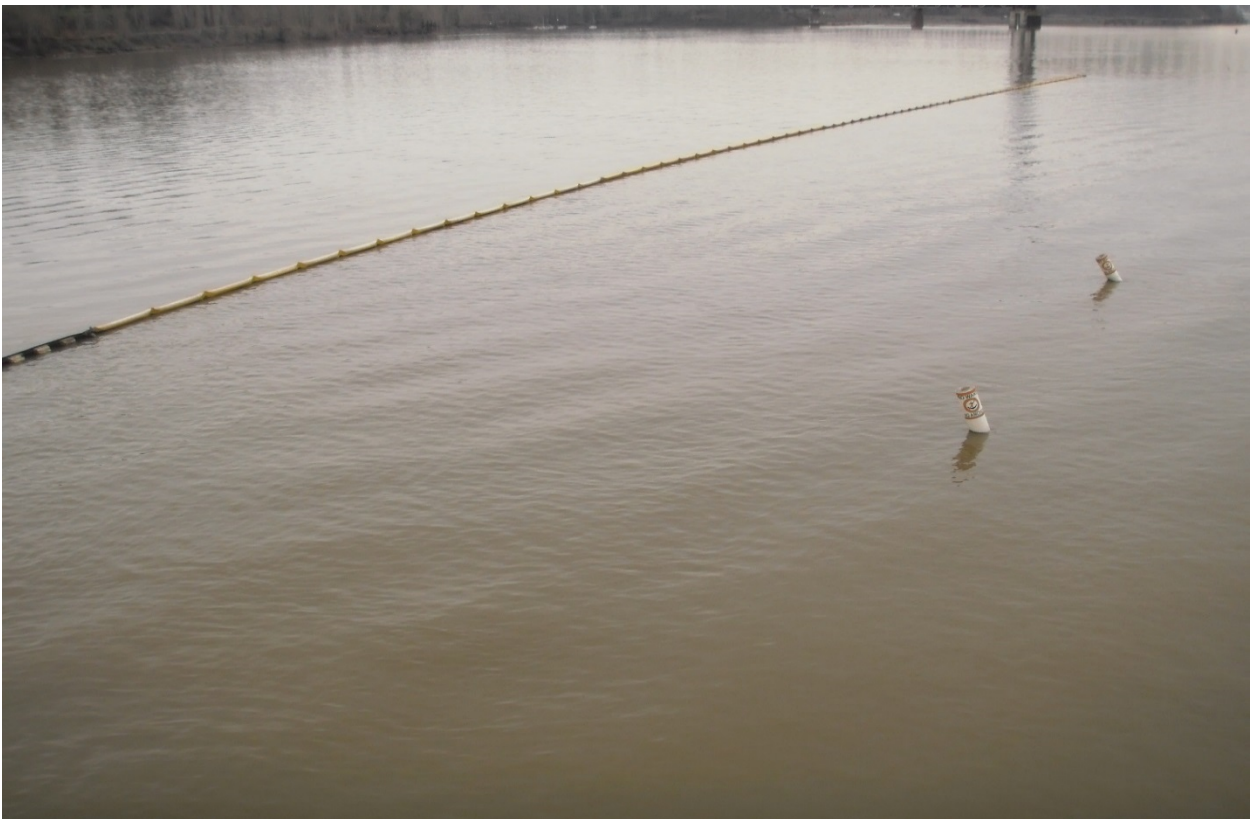
Observations of Long-term Controls (i.e., oil booms, organo-clay mat, etc.) During the observation, the FAMM containment boom was placed across the cap area, from dock to an anchor point riverward of the dolphin. Two buoys that identify the cap area to mariners are in place as installed. The position of the FAMM oil boom, warning buoys, and a general overview of the site shoreline is shown in Photo 2.

Photo 2 — *FAMM oil boom placement and mariner warning buoys identifying the pilot cap area. (1/20/16):*

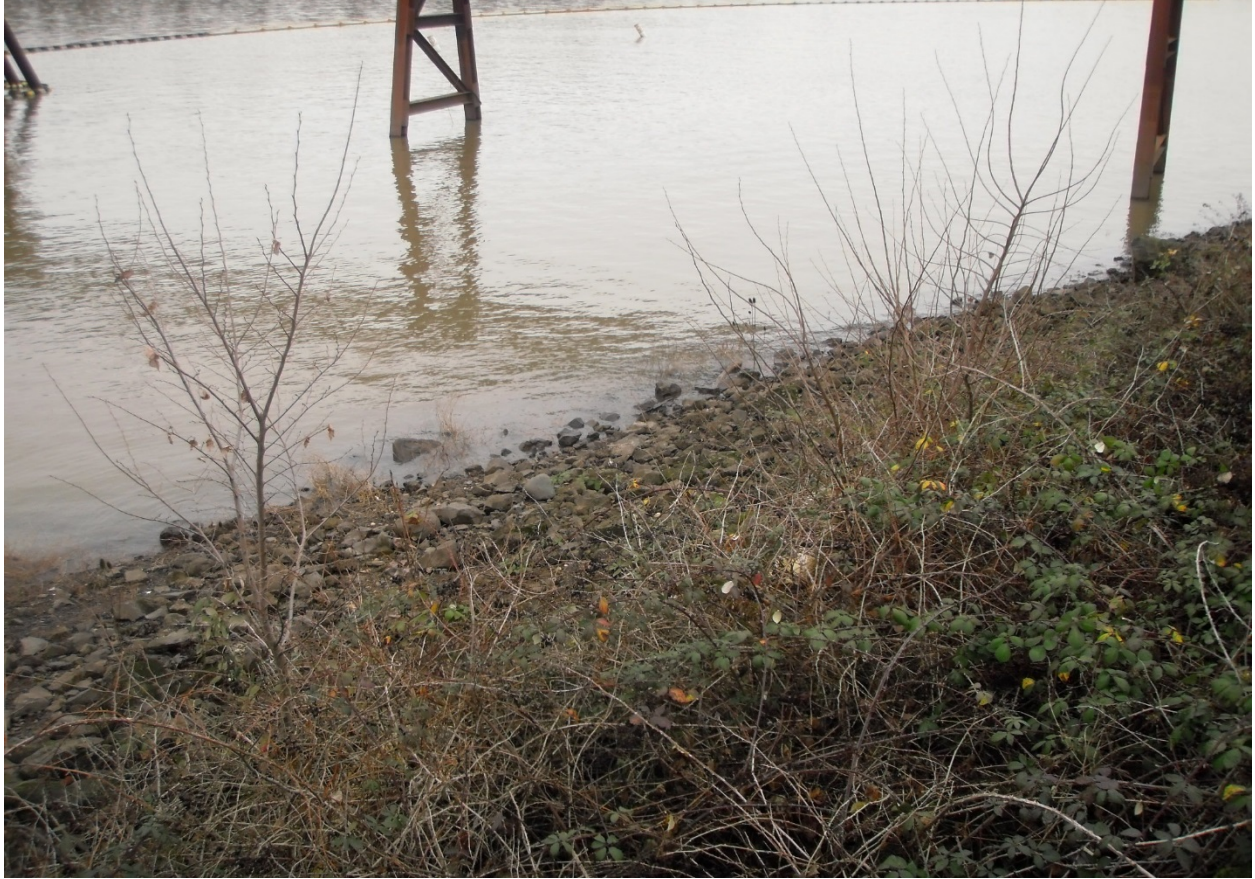
Other Comments: No sheen is evident in or around the cap area. Photo 3 shows the water surface and shoreline immediately downriver of the sediment cap.

Photo 3 — *Conditions immediately downriver of pilot cap area (1/20/16):*
